**BAT SPECIES AND HABITAT MONITORING AT THREE BRIDGE SITES  
IN BELL AND CORYELL COUNTY, TEXAS**

Prepared for  
Texas Department of Transportation  
Environmental Affairs Division  
125 East 11<sup>th</sup> Street  
Austin Texas 78701

30 September 2013

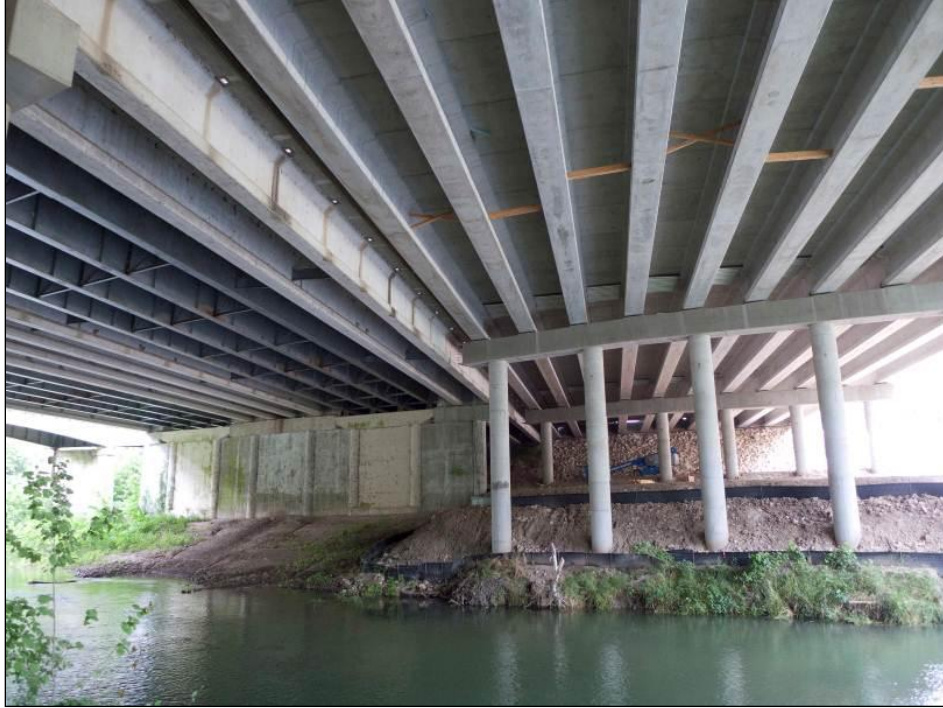
Figure 1.2. The underside of the Lampasas Bridge in Bell County, Texas, showing the existing main lane bridge (left side) currently occupied by bats. The area to the right side of the photograph shows the new main lanes currently under construction.

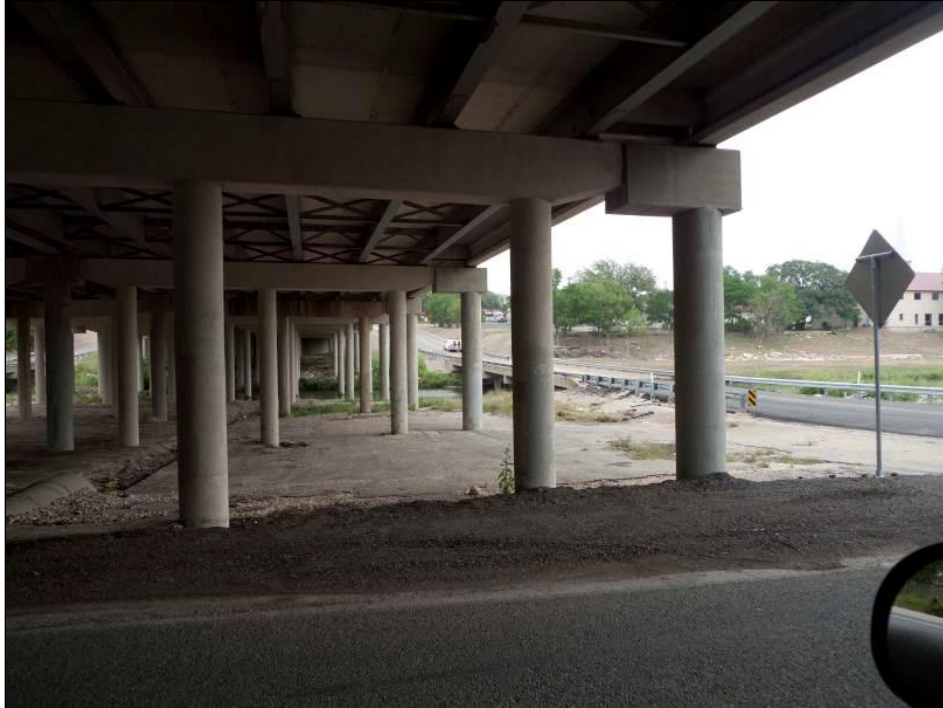
Figure 1.3. The underside of Salado Creek bridge in Bell County, Texas, showing the existing main-lane bridge (left side), currently occupied by bats.

The gap at the Salado bridge did not have the T-shaped extension; therefore, we measured the width and depth of the gap. In addition to the main gap at the Salado bridge, a single cross gap on the north end of the bridge was found to support roosting bats. Measurements for this cross gap were included in the gap volume calculations for the Salado bridge.

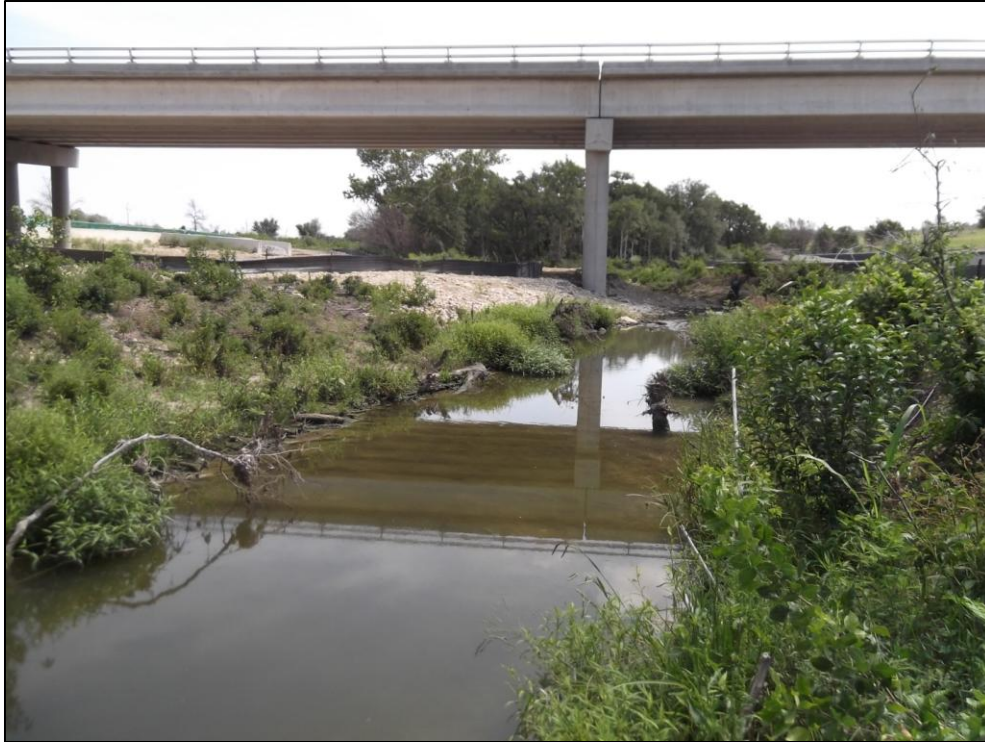
Figure 1.4. Turkey Run bridge in Coryell County, Texas. This site had no gap habitat and did not host a bat colony during the course of this study. The bridge is complete and the roadway is still under construction.

The Turkey Run bridge is located near Fort Hood military training installation. It is a newly constructed bridge, that was in fact still under construction at the time of this report, in a sparsely populated area. The area immediately surrounding Turkey Run has been heavily modified due to recent construction and consists mostly of bare, packed caliche. The areas up and downstream of the bridge are slightly less modified, but the area was subjected to overgrazing in the past (Figure 1.4).

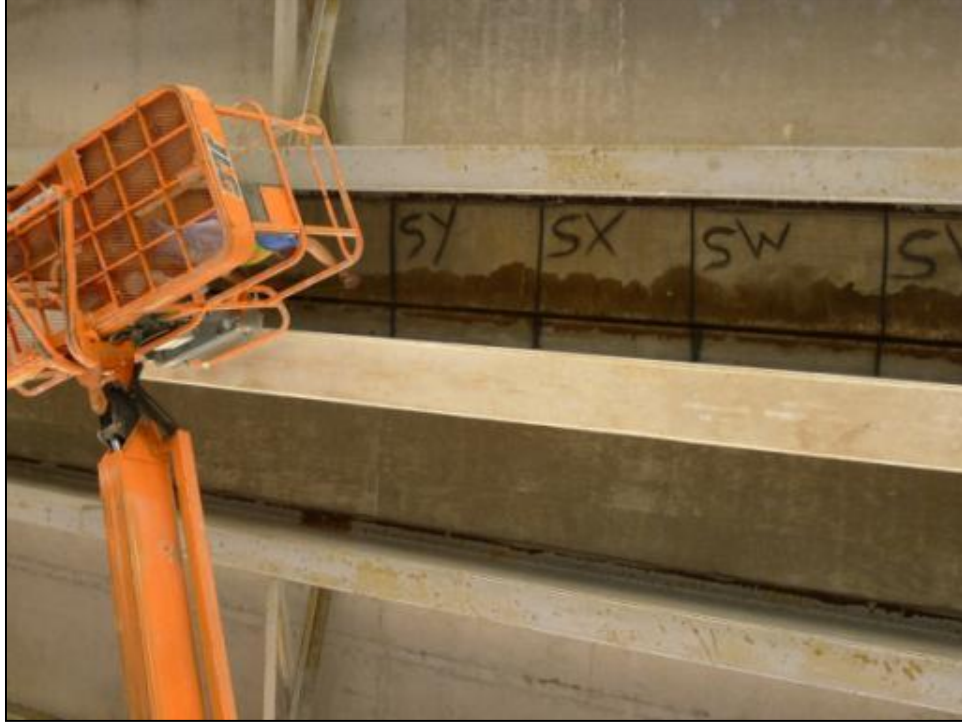
Figure 2.1. Each linear meter of the gap at the IH 35 bridges over the Lampasas River and Salado Creek in Bell County, Texas, were assigned an alphabetical identifier, which was semi-permanently marked directly on the underside of the bridge using spray paint. Also visible in the image are stains from bat urine.

We mapped the occupied gaps at the Lampasas and Salado bridges in one meter (m) long sections, and marked each section with a unique letter code to identify that specific meter-long section of the bridge (Figure 2.1). We used a boom lift, ladders, and technical ropework to access bridge sections that were out of reach. The gap areas that were not accessible for labeling were those directly over the rivers. Because the labels were intended to facilitate bat counts within the gap habitat, there was no need to mark Turkey Run Bridge, which contained neither gap habitat nor bats.

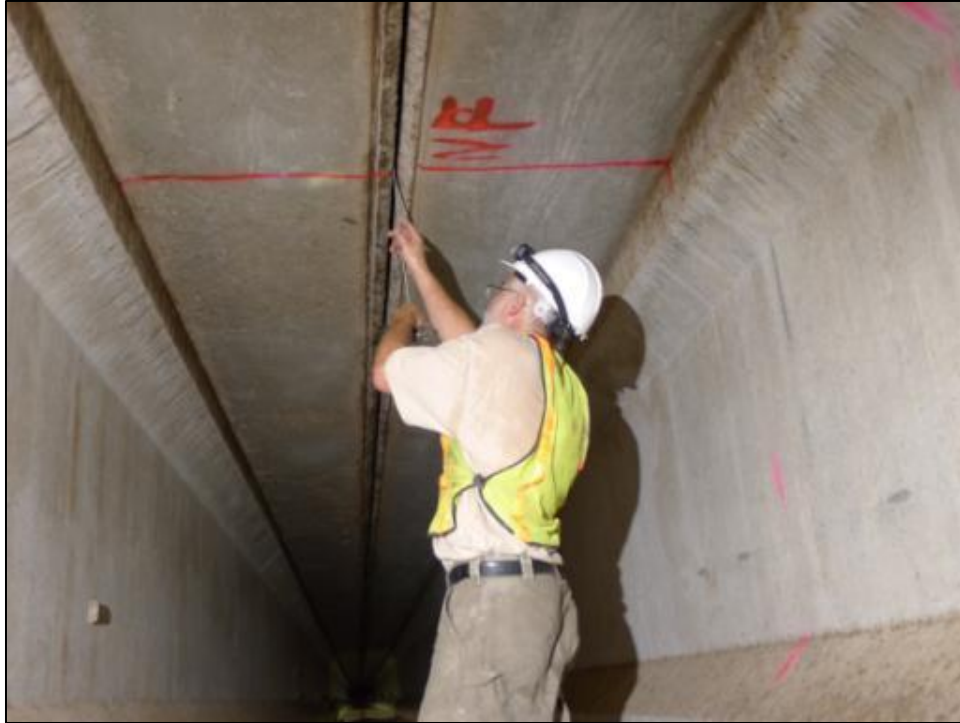
Figure 2.2. The width and depth of each gap segment at the IH 35 bridges over the Lampasas River and Salado Creek in Bell County, Texas, were measured to the nearest centimeter in order to calculate the volume of the available habitat.

The width and depth of the gap at the end of each section was measured to the nearest centimeter (cm) (Figure 2.2). The top of the gap at the Lampasas bridge extended into a T shape (Figure 2.3), which we measured using a stiff bent wire of known length (Figure 2.4). The main gap measurements for width and depth over each meter long segment were multiplied together. For calculations at Lampasas, these were added to the volume of each segment of the T-shaped extension, whose volume was also calculated by multiplying the width and depth of each side of the T over the one meter segment.

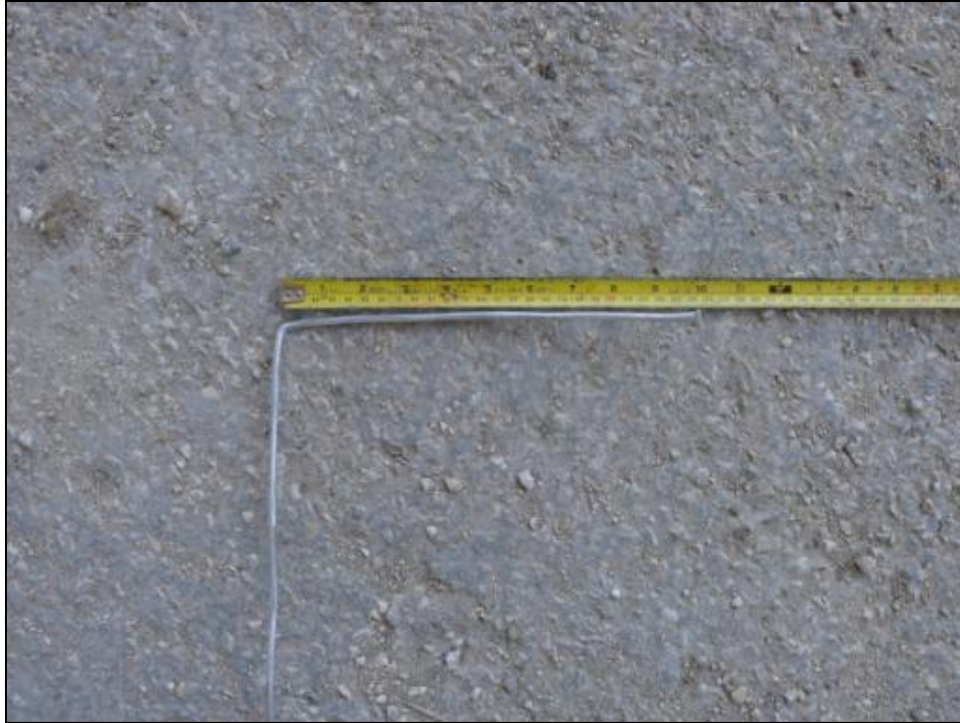
Figure 2.4. The width of the T at the top of the gap at Lampasas bridge, Bell County, Texas, varied along the length of the bridge. Stiff wire of varying known lengths was used to estimate the width at each meter.

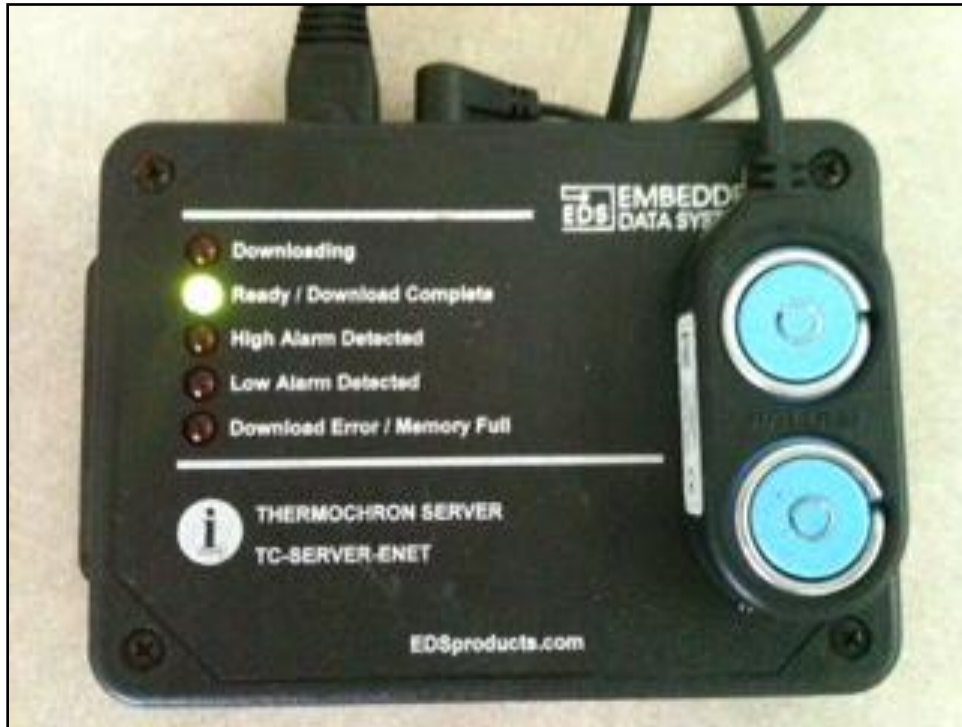
Figure 2.5. ThermoChron Server from Embedded Data Systems used to download iButton data.

We installed 40 iButton DS1923 Hygrochron temperature/humidity loggers to record temperature and relative humidity within, alongside of, and away from the bat-inhabited gaps at Lampasas and Salado bridges, and on the underside of the Turkey Run bridge. Loggers were missioned and downloaded using an Embedded Data Systems ThermoChron Server (Figure 2.5). Temperature and relative humidity were logged every 30 minutes at resolutions of 0.5°C and 0.6 percent, respectively (Figure 2.6) from September 2011 to

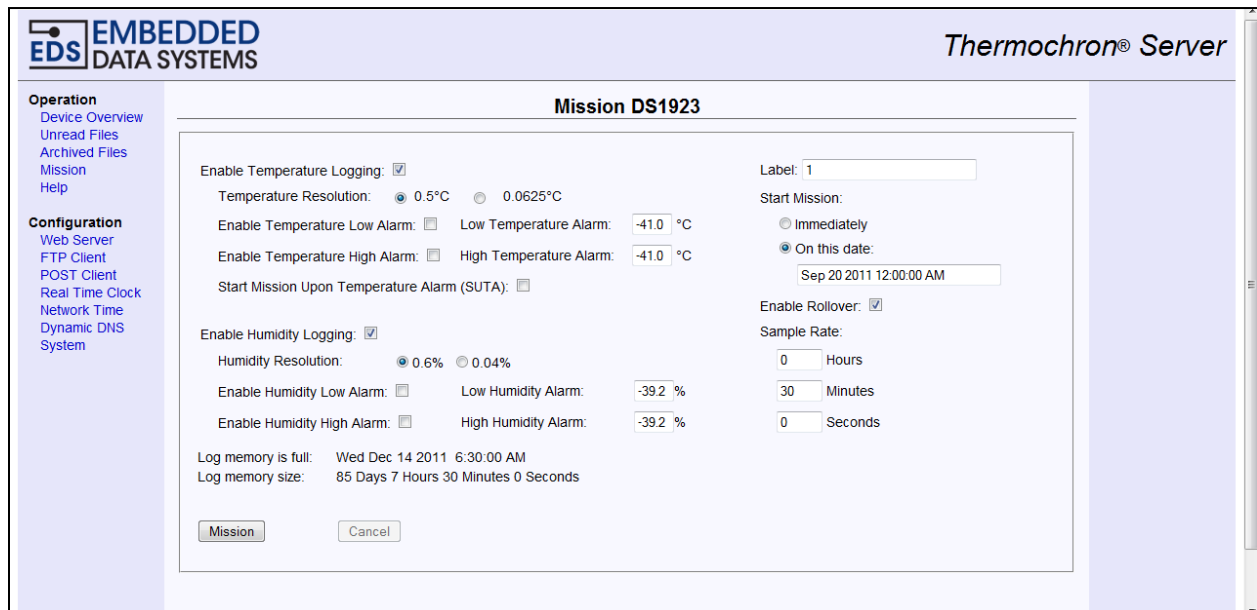
Figure 2.6. Mission settings for iButton data loggers.

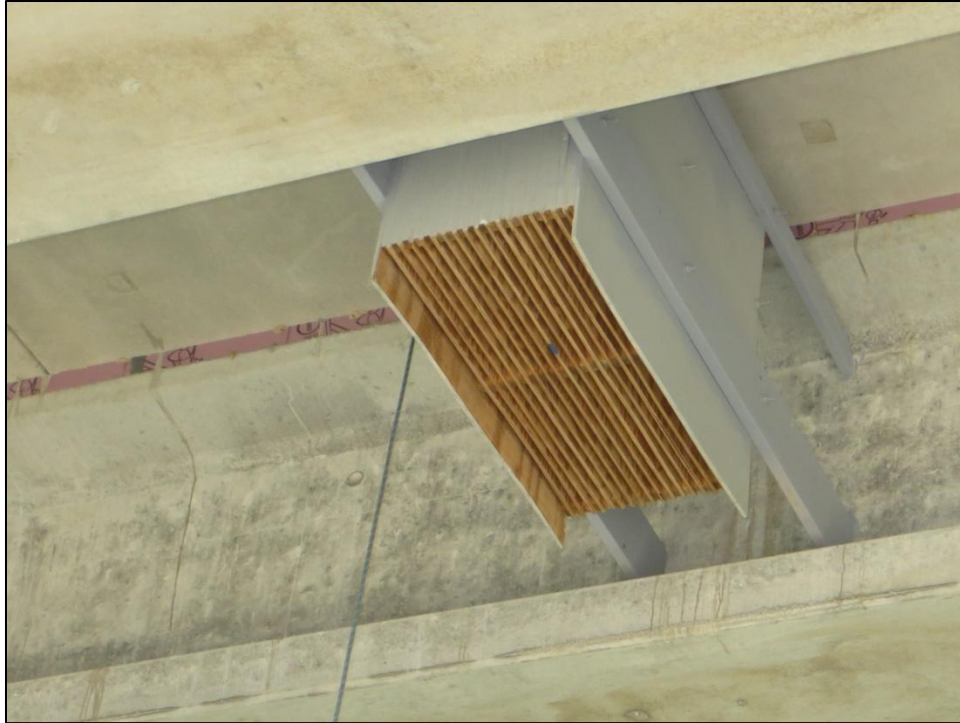
Figure 2.8. An installed bat house at the Lampasas bridge, Bell County, Texas, showing rope access for future monitoring.

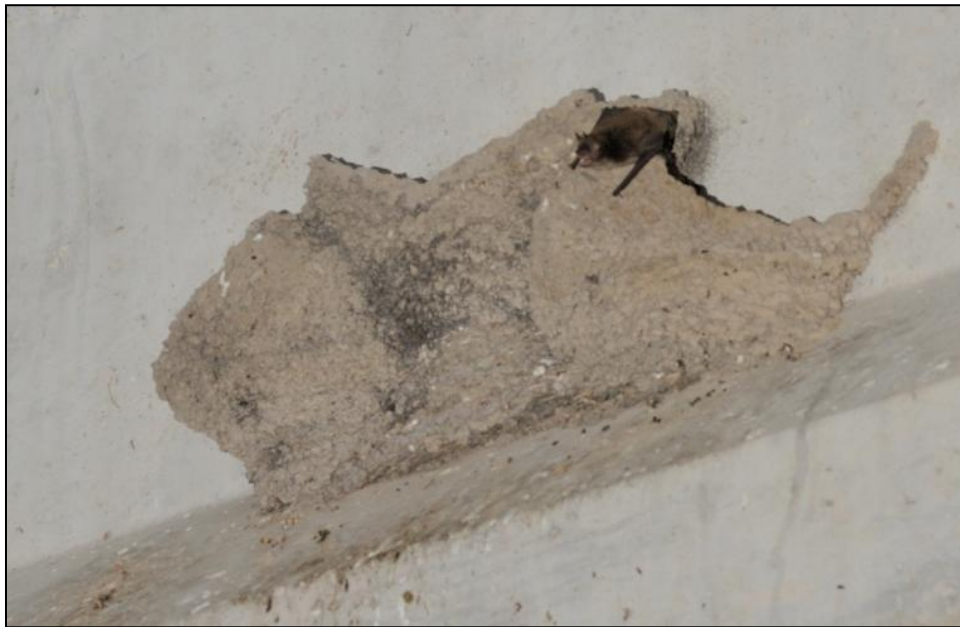
Figure 2.12. A bat leaving a nest built by a swallow along a bridge beam.

We documented approximately 90 swallow nesting sites at the Lampasas bridge (Appendix C.5) and approximately 96 at the Salado Bridge (Appendix C.6), with several of them supporting multiple nest cavities/openings. Pigeon activity at both bridges peaked in fall, and swallow activity at Lampasas peaked in early summer (Figure 2.11). We observed an average of 23 swallows and 11 pigeons at Lampasas bridge, and 21 swallows and 17 pigeons at Salado bridge over 19 observation dates (Appendix C, Table C.3). Occasionally, we found bats occupying nests built by swallows (Figure 2.12). We also documented pigeons roosting at both bridge sites.

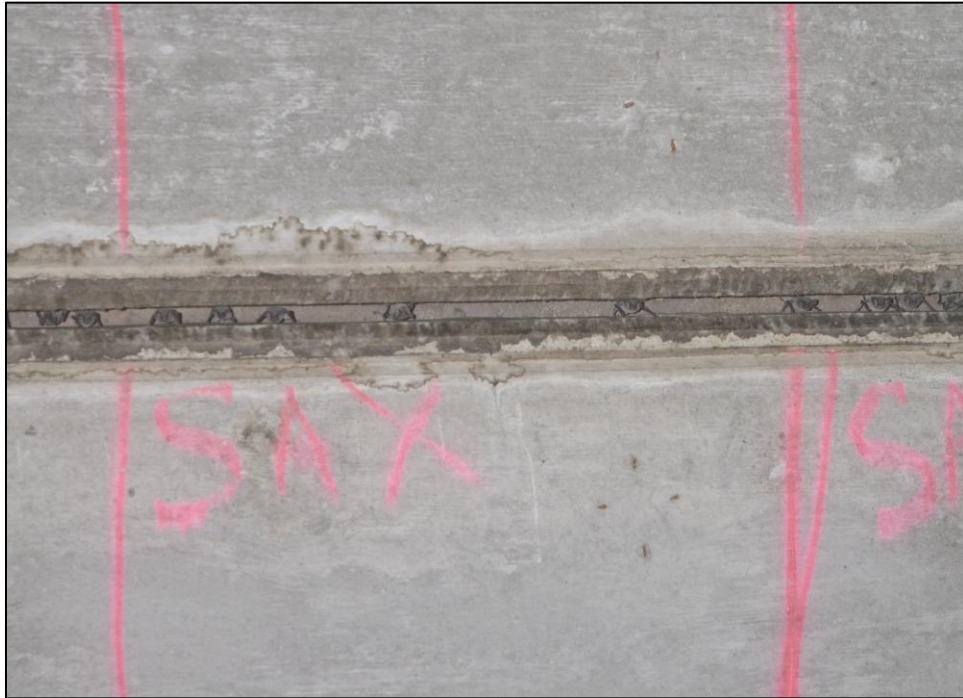
Figure 3.1. Image of one labeled meter of gap at Lampasas bridge, Bell County, Texas, from 11 August 2012, with section enlarged and lightened showing two bats.

We reviewed photographs on the digital camera while in the field to ensure image quality. In the lab, we counted individual bats by enlarging the photographs on a computer screen and recording the number of bats in each marked one meter section and in the unmarked span over the water (Figure 3.1).

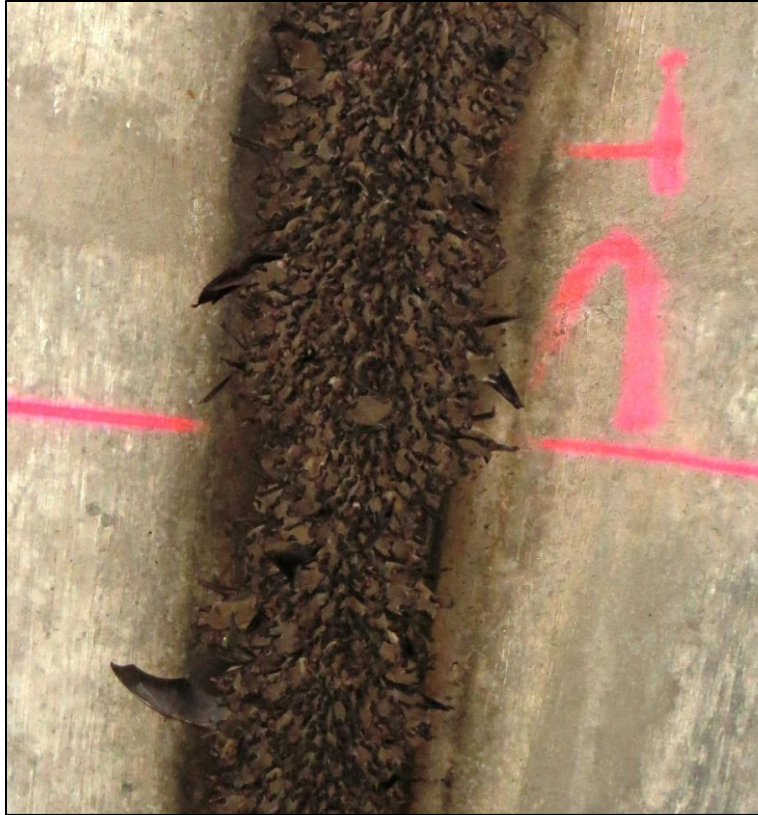
Figure 3.2. Bats stacked several deep into the gap and bulging out of the gap during periods of high occupation at the Lampasas bridge, Bell County, Texas.

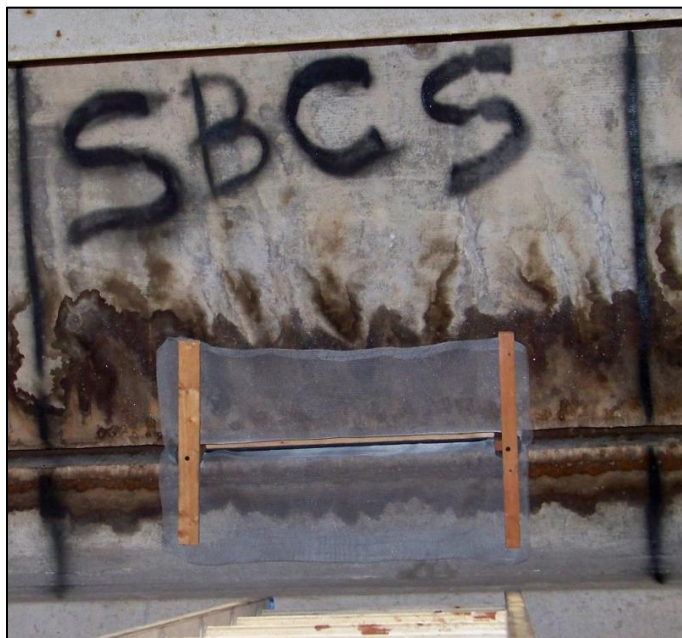
Figure 3.3. Bat traps spanned half of the one meter section and allowed us to determine how deep the bats were stacking.

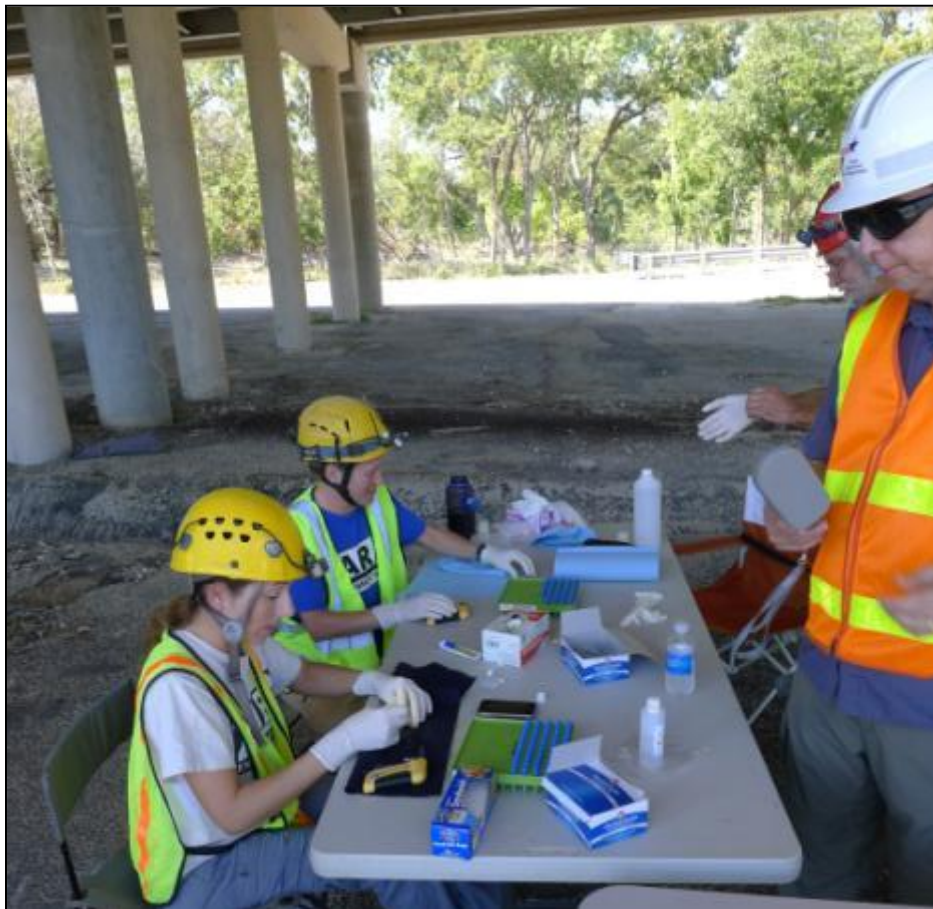
Figure 3.6. Field processing station for tagging bats at the Salado bridge, Bell County, Texas.

Based on the lack of negative results from bats in the test group, PIT tags were injected subcutaneously into 347 bats at the IH 35 bridge over the Lampasas River (Lampasas bridge) and 349 bats at the Salado bridge in the fall of 2011 (Figure 3.6). The third bridge discussed elsewhere in this report, SH 9 over Turkey Run Creek, was not included in this analysis because it did not have an existing bat population during this study. In order to access the gap habitat for recapture, we bolted anchors into the concrete beams of the bridges, and hung ropes from those anchors. We then used standard single rope technique ascending and descending methods (Padgett and Smith 1987) to climb to the anchor and access the bats in that area. Unfortunately the bats quickly learned to avoid those areas, so we created a trolley system to access an entire span of gap habitat between bridge bents. This system consisted of tensioned cables rigged around the bents with a 2 in by 12 in lumber platform as the trolley, coupled with an independent safety line anchored into the bridge beams (Figure 3.7).

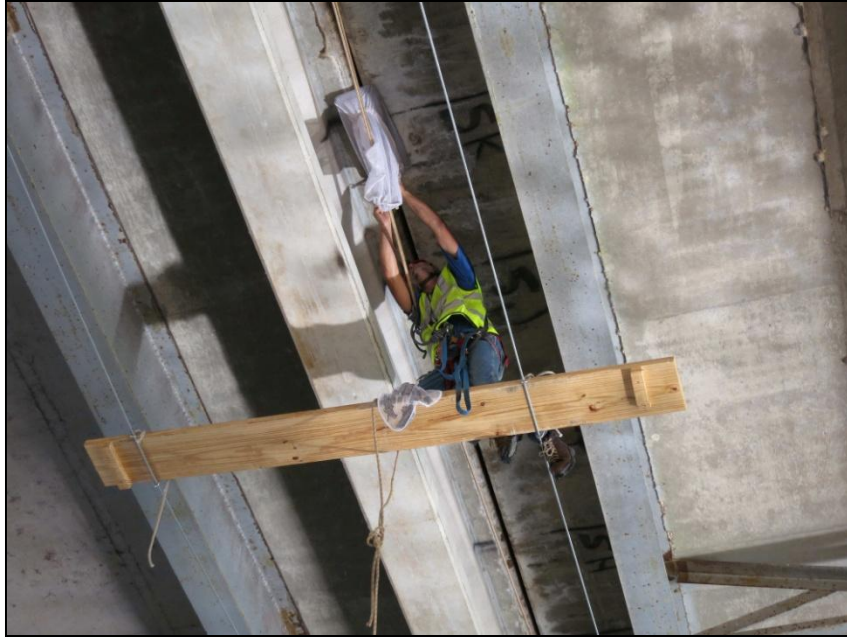
Figure 3.7. Trolley systems were installed under both the Lampasas and Salado bridges, Bell County, Texas, to allow us to access more of the gap than ropes alone.

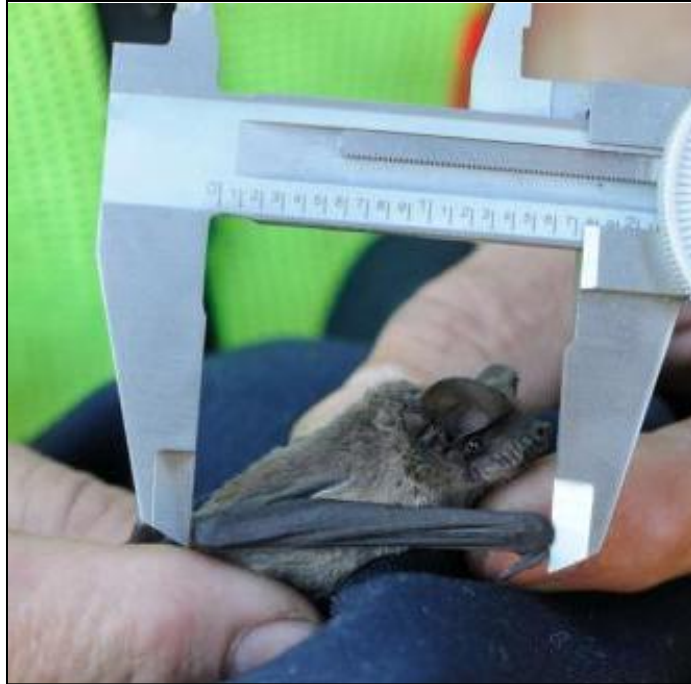
Figure 3.10. Calipers were used to measure forearm length of bats that would receive PIT tags.

The metrics we recorded for tagged bats included weight, forearm length (Figure 3.10), gender, reproductive status when obvious, and age (juvenile or adult) based on wing joint ossification (Figure 3.11, Figure 3.12). We scanned tagged bats with a hand held Biomark 601 tag reader after injection to ensure that tags could be read (Figure 3.13). We recorded the same metrics for bats captured during the summer of 2012, but did not record metrics for bats captured during the spring of 2012. We performed a t-test to determine whether sex ratios were significantly different between the two bridges and whether body condition index (BCI) was different between sexes.

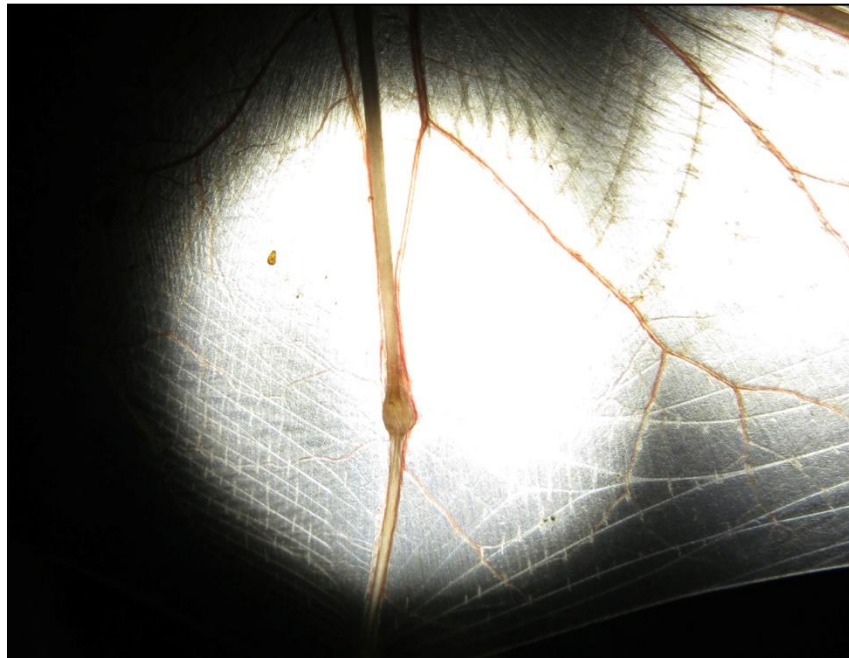
Figure 3.11. Fully ossified wing joint of adult Brazilian free-tailed bat.

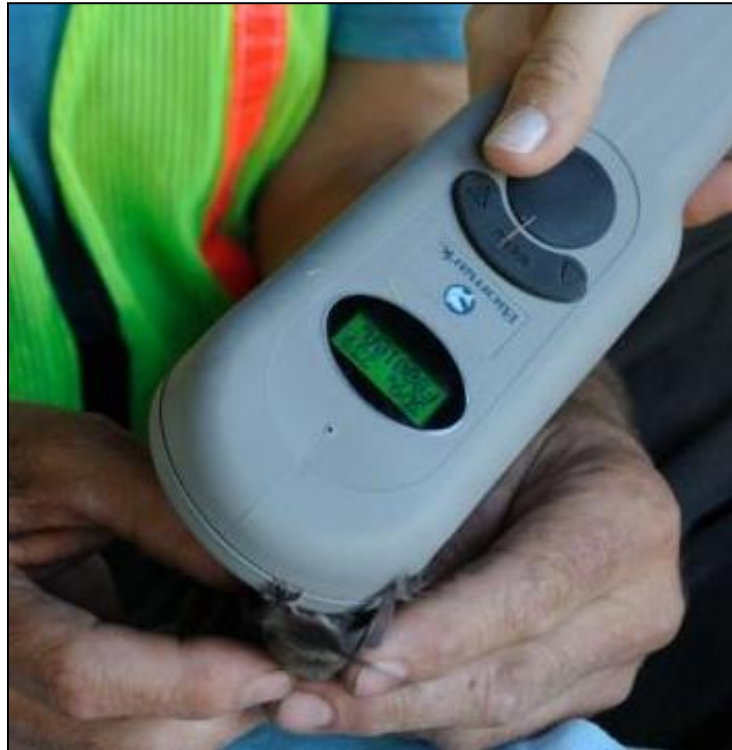
Figure 3.13. Bats were scanned with a hand held tag reader after implantation.

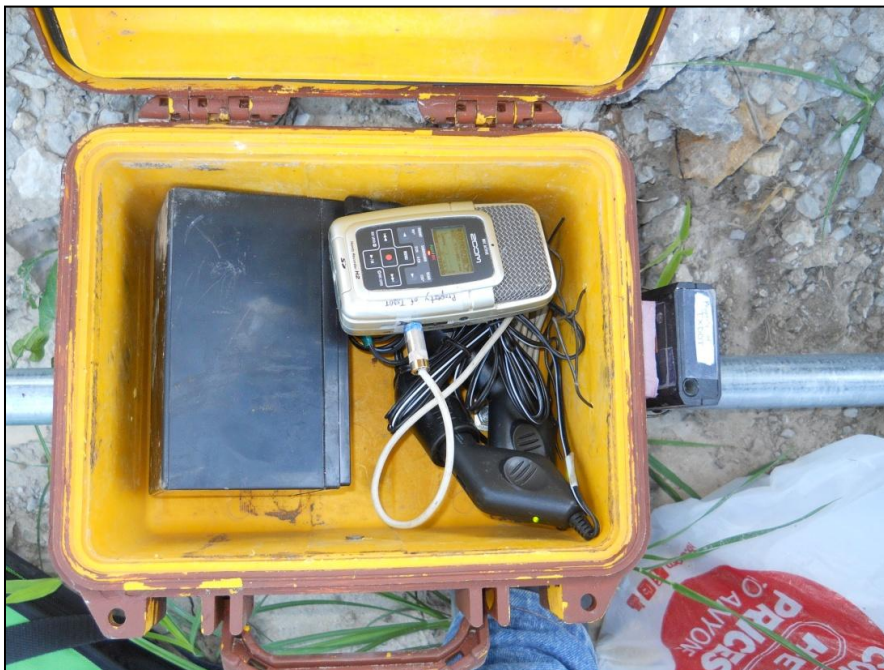
Figure 3.14. Zoom H2 recorded, external battery and Peterson D240X bat detector mounted within and on top of a Pelican case.

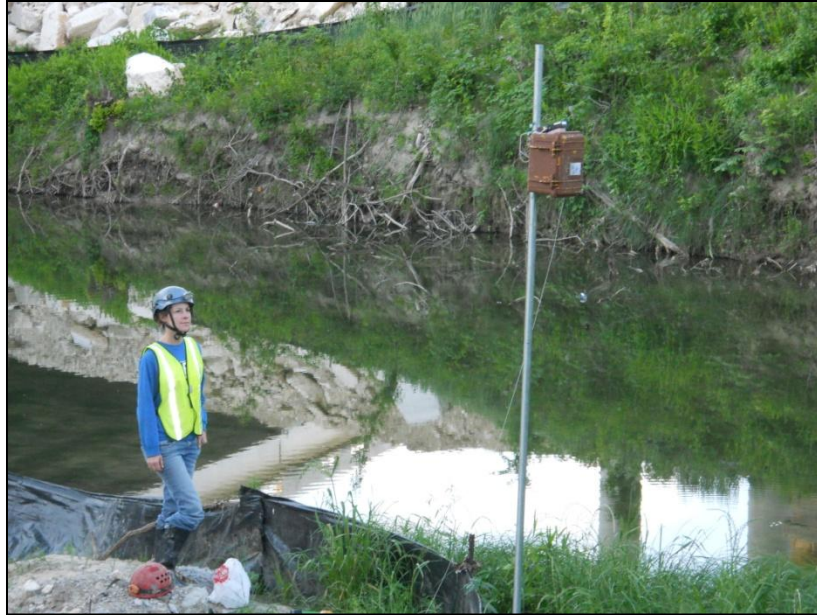
Figure 3.15. The bat detector was set up in the exact same spot during each evening of recording.

We performed two nights of experiments on exact placement of the detector to maximize bat detection and minimize interference from the ground (water reflections, insects, frogs), from trees, and from the bridge structures themselves. These experiments included observations of the direction that bats from the colony typically exited (e.g. upstream vs. downstream), field downloads from the detector to a laptop to evaluate file quality, then changing detector configuration, examining the files, and repeating until the quality was maximized. The recorder and external 12v battery were contained in a locking Pelican case with the D240X secured to the top of the case on a triangular shaped wood block (Figure 3.14). We designed the block to aim the microphone slightly upwards into the flight path. The entire setup was affixed to a 10 ft. galvanized steel pole which was placed in a concrete bucket stand that was put in the exact same place every night (Figure 3.15).

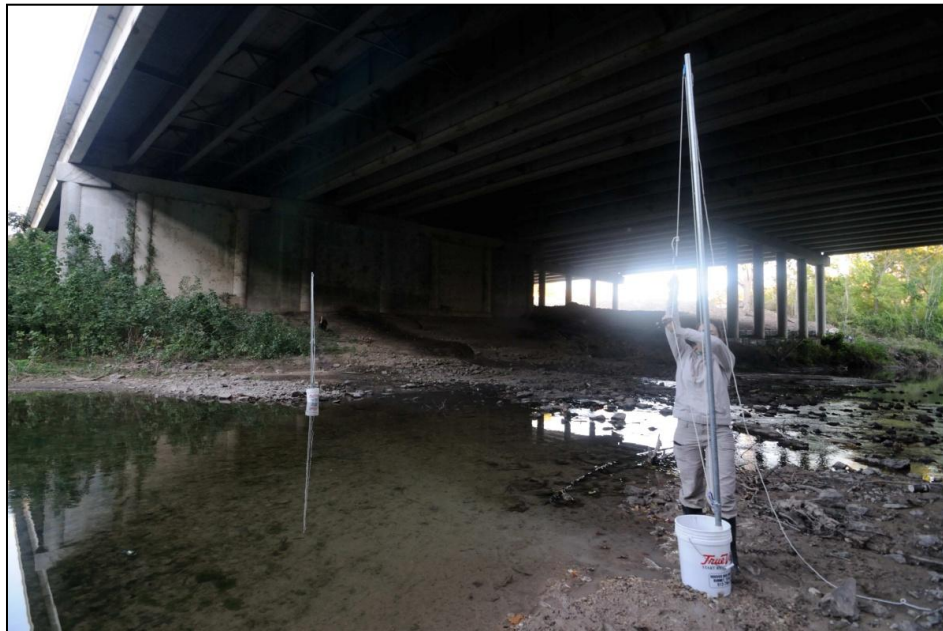
Figure 3.16. Mistnetting at the Lampasas bridge, Bell County, Texas.

We deployed single-high mistnets on eight occasions during the fall of 2011. We set up mistnets over accessible portions of the waterway where we determined it likely for bats to fly. At the Lampasas and Turkey Run bridge, the net was set up near the bridge itself (Figure 3.16); however at the Salado bridge the net was deployed upstream of the bridge near a still pool where we suspected bats would be more likely to drink (Figure 3.17).

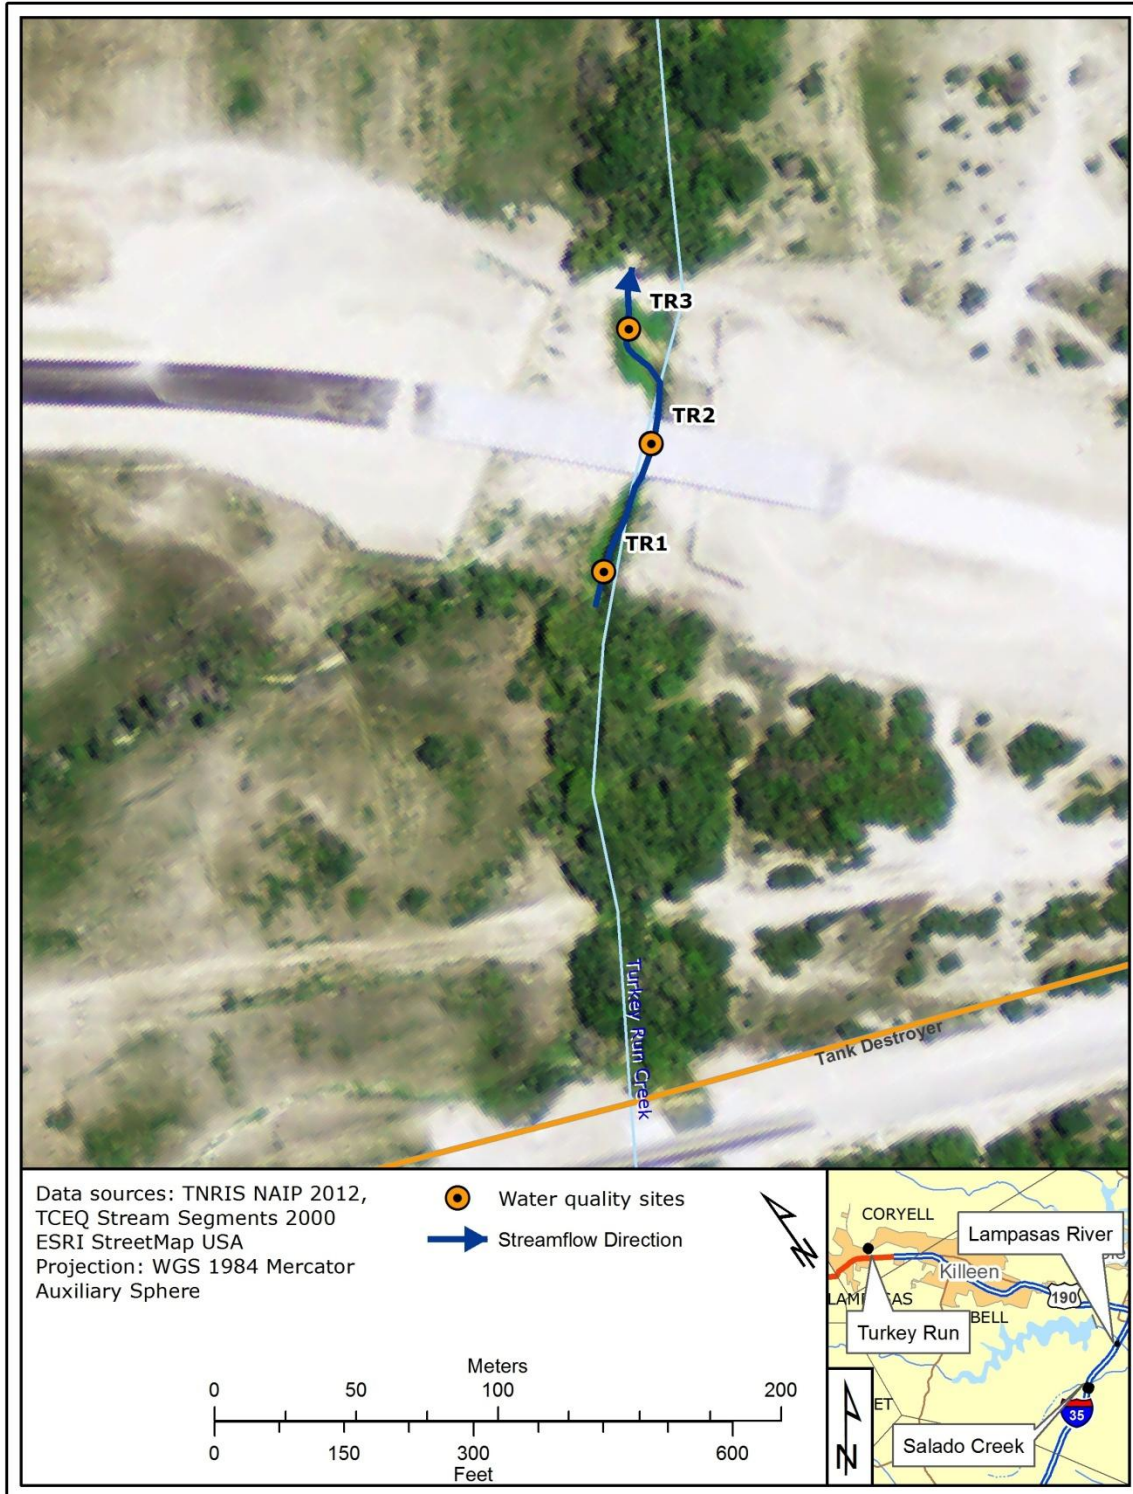
Figure 4.4. Water quality sampling locations at the Turkey Run bridge, Coryell County, Texas.

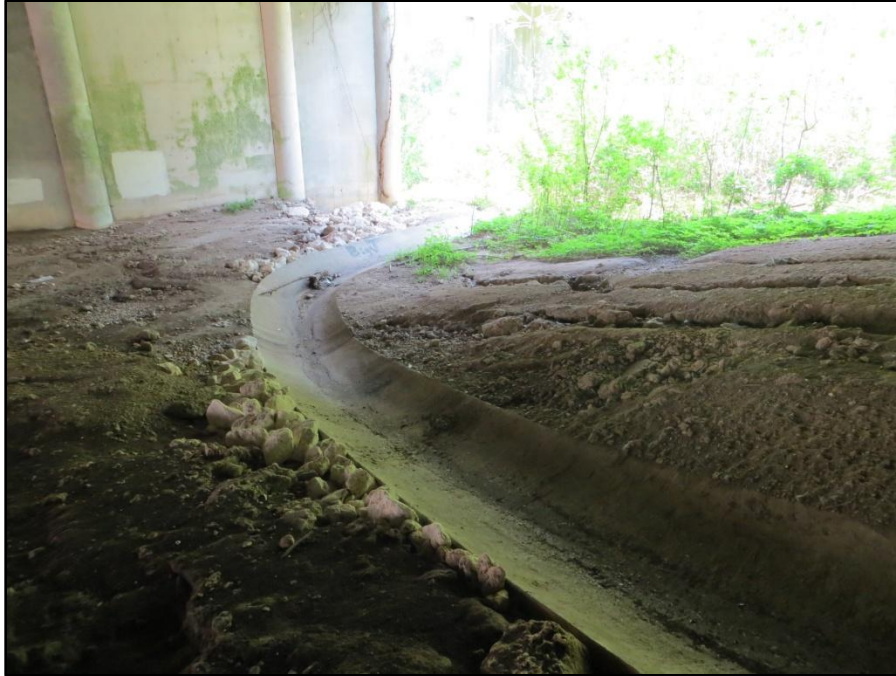
Figure 4.5. Concrete drainage gutter that conveys storm water from the outfall underneath the north side of the Lampasas bridge, Bell County, Texas. Bat guano can be seen in the gutter.

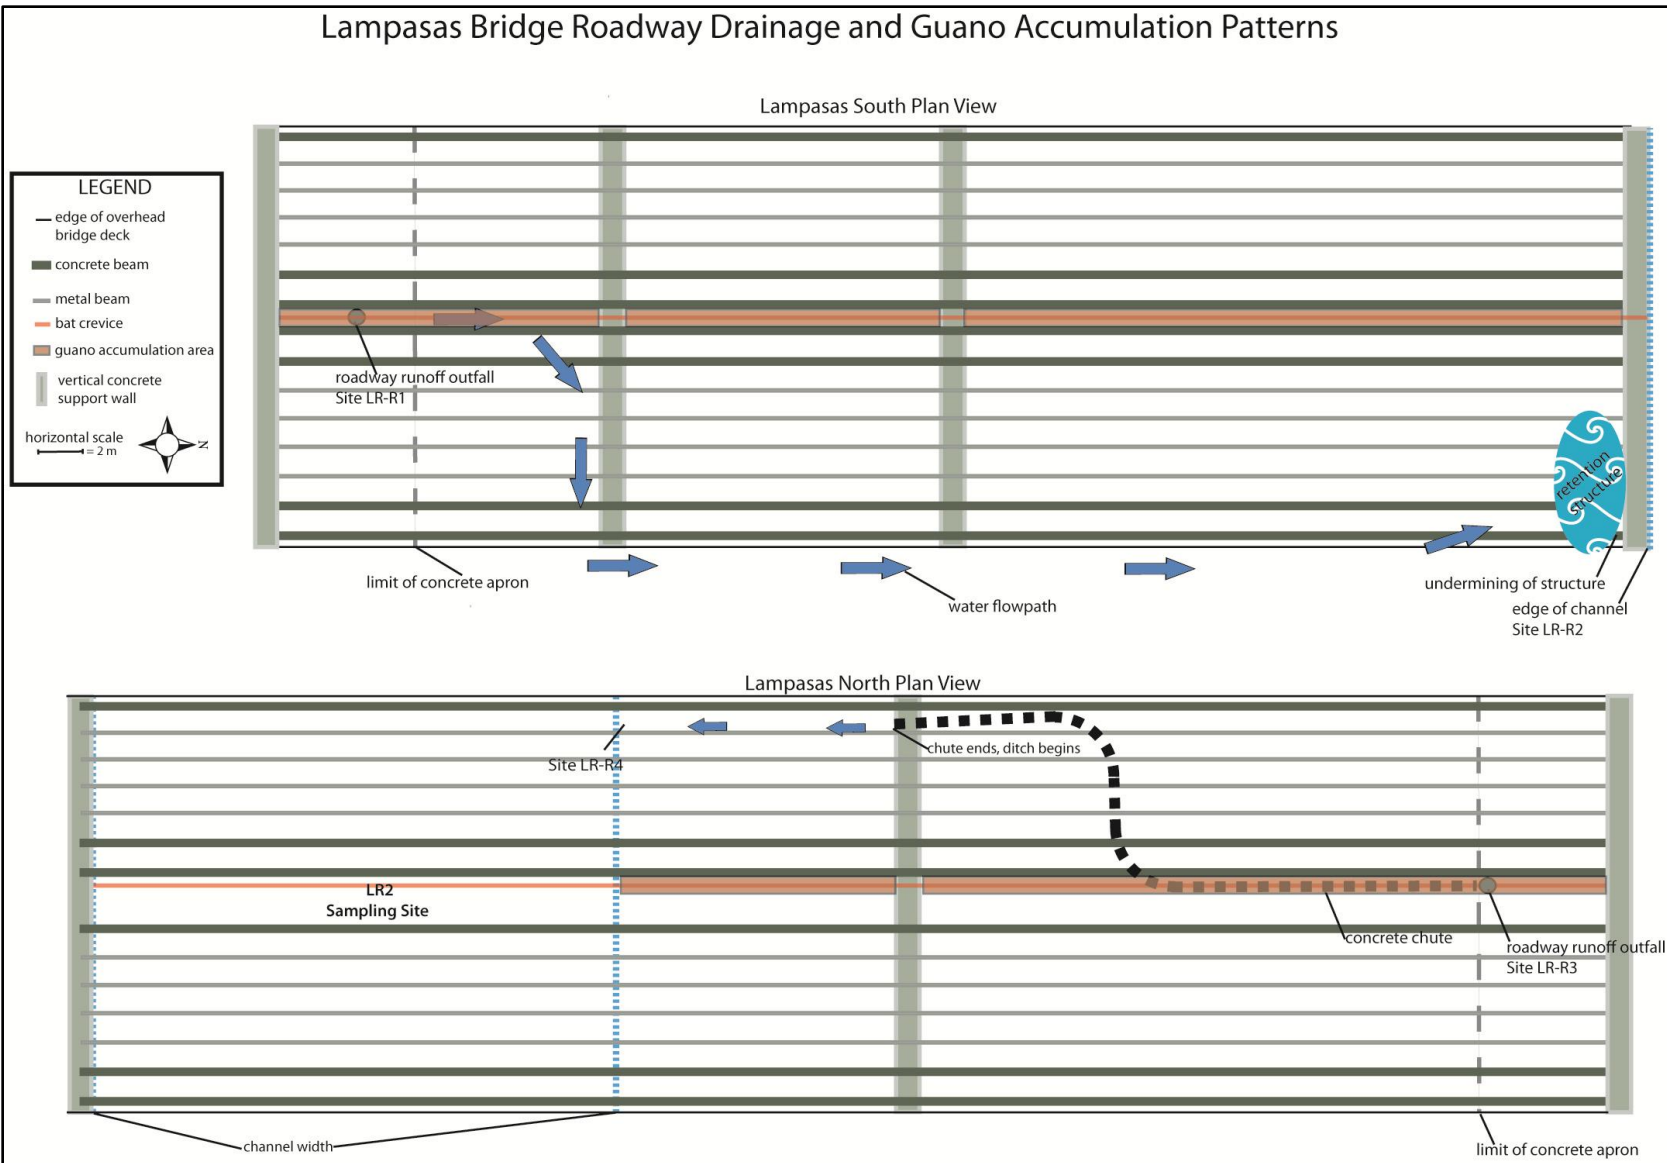
# Lampasas Bridge Roadway Drainage and Guano Accumulation Patterns

Figure 4.6. Drainage and bat roosting patterns underneath the Lampasas bridge, Bell County, Texas.

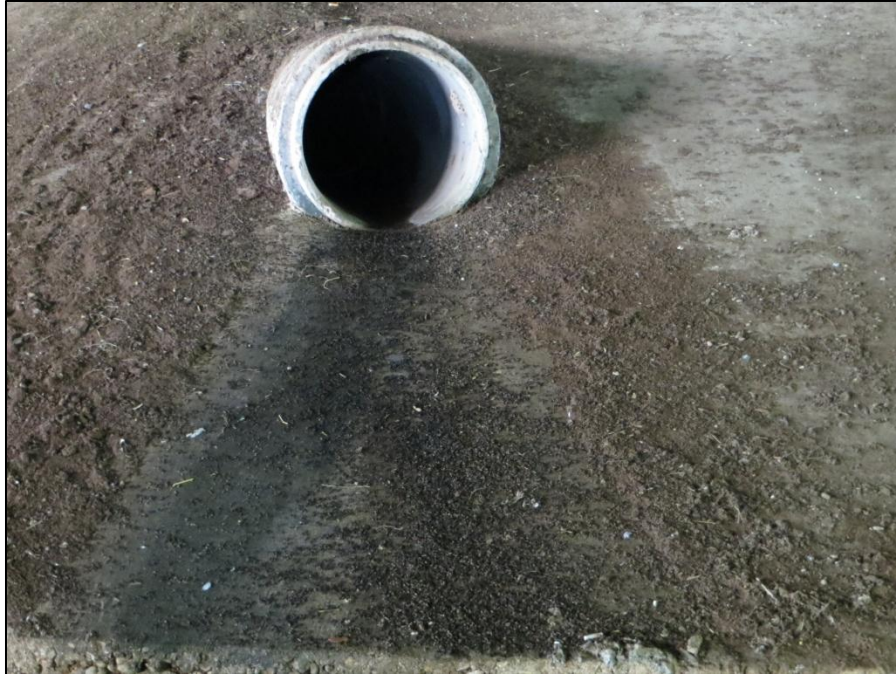
Figure 4.10. Storm water outfall under the south side of the main lanes of the Lampasas bridge, Bell County, Texas. Note the newer guano deposits (black) that have accumulated since the last rainfall event and the older, thicker guano deposits (brown) that are not washed away by storm water.
